## To Restore or Not to Restore: Assessing Pre-project Conditions of a Habitat Restoration Project on the New River, North Carolina

Bobbie Swinson<sup>1</sup> · Kristan Cockerill<sup>2</sup> · Jeffrey Colby<sup>1</sup> ·  
Shea Tuberty<sup>3</sup> · Chuanhui Gu<sup>4</sup>

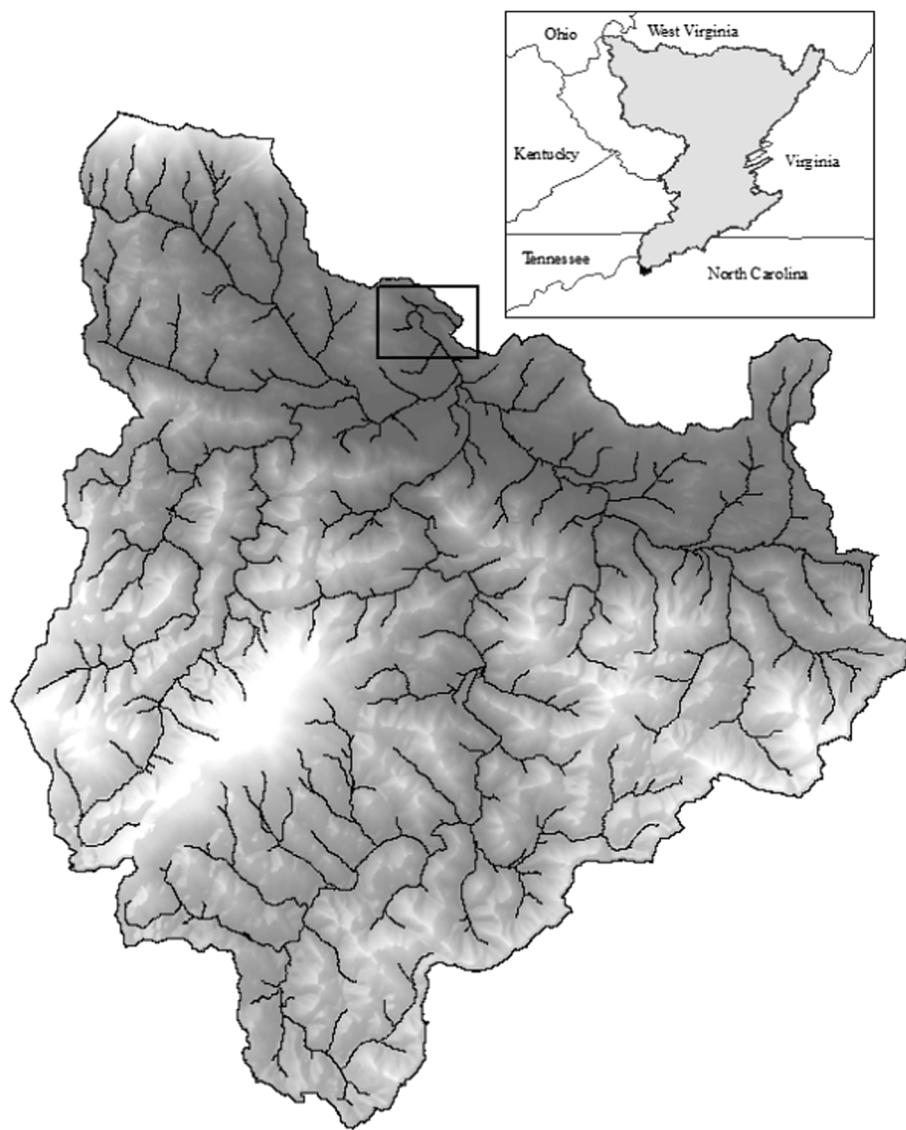
**Fig. 1** Study area. The location of the restoration project (*solid rectangle*) is at the outlet of the Upper South Fork New River watershed, which represents the headwaters of the South Fork of the New River in Boone, North Carolina. The South Fork is a tributary of the New River, and part of the Ohio River drainage basin

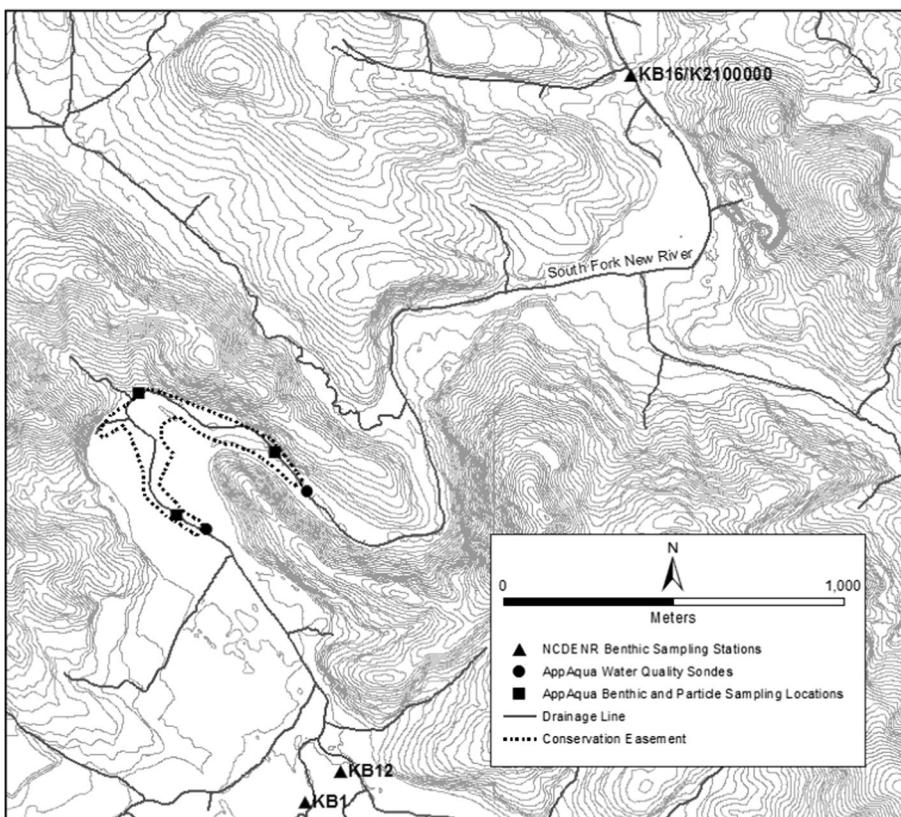
**Fig. 2** Monitoring stations. North Carolina Department of Environment and Natural Resources benthic monitoring stations located upstream and downstream of the restoration reach. Station KB16 also serves as NCDENR ambient water quality monitoring station K2100000. AppAqua benthic, sediment, and water sonde locations within the restoration reach

AppAqua researchers collected and analyzed macroinvertebrate populations within the study area in April of 2013. The restoration reach was divided into three sections based on the geomorphic characteristics of the channel. The two large bends in the river create a distinct upper, middle and lower reach, which was conducive to sampling and analysis of macroinvertebrate populations from similar riffle habitats (Fig. 2).

Data from the NCDENR AMS station located in the same geographic location as benthic station KB16 (Fig. 2) were used to draft the EA in 2009. Dissolved oxygen, specific conductivity, pH, total suspended solids, turbidity, and nutrient data collected via grab samples were reported in the EA in the form of minimum, median, and maximum values from 1998 through 2003.

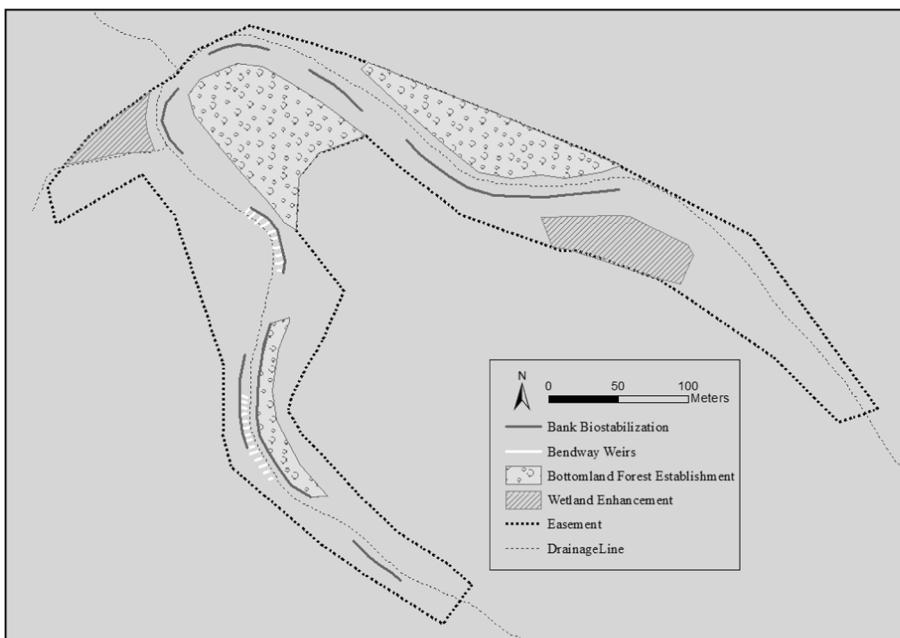
**Fig. 3** Overall site plan for the restoration. Primary restoration measures include rehabilitation of wetland areas, invasive species control and re-vegetation, riparian buffer extension and establishment, and bottomland hard-wood forest re-vegetation as well as installation of bendway weirs to direct water away from river banks. Source: USACE (2009)

Channel and stream bank stabilization will be attempted by installing anchored slab bundles at the toe of unstable slopes, bank grading and vegetation, and installing bendway weirs. Additionally, clusters of large boulders will be placed to help direct the flow towards the center of the channel and away from the stream banks. An overall site plan is shown in Fig. 3.

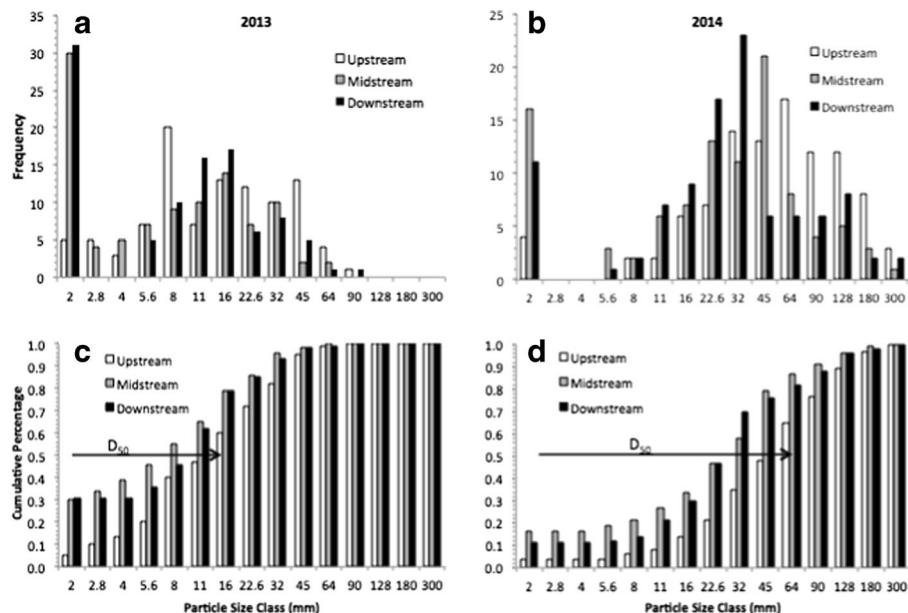
**Fig. 4** 2013 and 2014 riverbed coarse particle size distributions. Shown above are the results of 100 riverbed particles randomly selected from ten 10-m transects at each of the upper, mid and downstream reaches. Notice that ~30 % of the particles are in the smallest class in the mid and downstream reaches. Cumulative percentages of riverbed coarse particle size distributions are the sum of size class percentages from results from 100 riverbed particles randomly selected from ten 10-m transects at each of the upper, mid, and lower reaches. The  $D_{50}$  for the upstream, midstream and downstream reaches was 16, 8, and 11 mm, respectively, for 2013. Note that in 2014 the  $D_{50}$  for the upstream reach was 64 mm, while midstream and downstream reaches were 32 mm

**AppAqua Riverbed Coarse Particle Size Assessment** As illustrated in Fig. 4, the distribution of very small size riverbed materials in the riffles of mid and downstream reaches were 2 to 6 times greater than that of the upstream reach, while the upstream reach typically had far more numbers of large size classes. Given that the worst of the bank erosion was found in the downstream reach and the small tributary joined the river there, this may support the presence of an adverse effect from bank erosion on benthic habitat in the downstream reaches of the restoration area.

standard for trout streams, and particle size data (Fig. 4) reveal that there has been substantial improvement in riverbed habitat quality, possibly from the 2013 record rainfalls and increased summer flows removing the fine particulates and sand from the reach. Interstitial spaces between the benthic substrate particles are actually the “habitat” that house the eggs and larvae of many aquatic animals. The small particles that enter the river from bank erosion can cause increased coarse riverbed particle embeddedness. However, the data show that there was a significant reduction in the amount of small particles, and therefore, an increased quality of the benthic habitat for meiofauna such as macroinvertebrates as well as eggs and larvae of fish and amphibians. Because we only had 2 years of data available for this analysis, and the second year was concurrent with record setting rainfall, we cannot say conclusively what is responsible (natural variation or the increased flows) but we can show that the benthic substrate was improved in 2014. Because the benthic macroinvertebrates were already excellent, the improved riverbed should continue to support as good or better community assemblages.

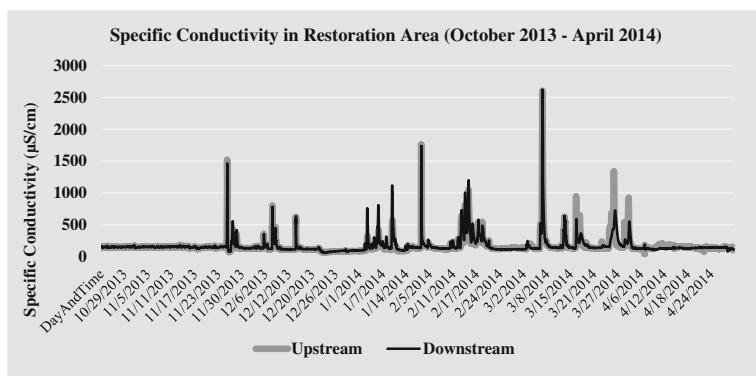
**Fig. 5** Specific conductivity ( $\mu\text{S}/\text{cm}$ ) as measured at AppAqua water quality monitoring stations. One sonde is located at the upstream end of the project (lighter line), and another is located at the downstream end (darker line). Significant spikes in conductivity are seen during winter storms and rain events. Typically the sondes have similar measurements, however, during precipitation events the measurements between sondes may deviate from each other. This indicates that runoff between the sondes could be influencing water quality in the reach
